# **INDOOR AIR QUALITY ASSESSMENT**

**EOHHS Service Center  
Shetland Park Office Complex  
45 Congress Street  
Salem, MA**

Prepared by:  
Massachusetts Department of Public Health  
Bureau of Environmental Health  
Indoor Air Quality Program  
August 2017

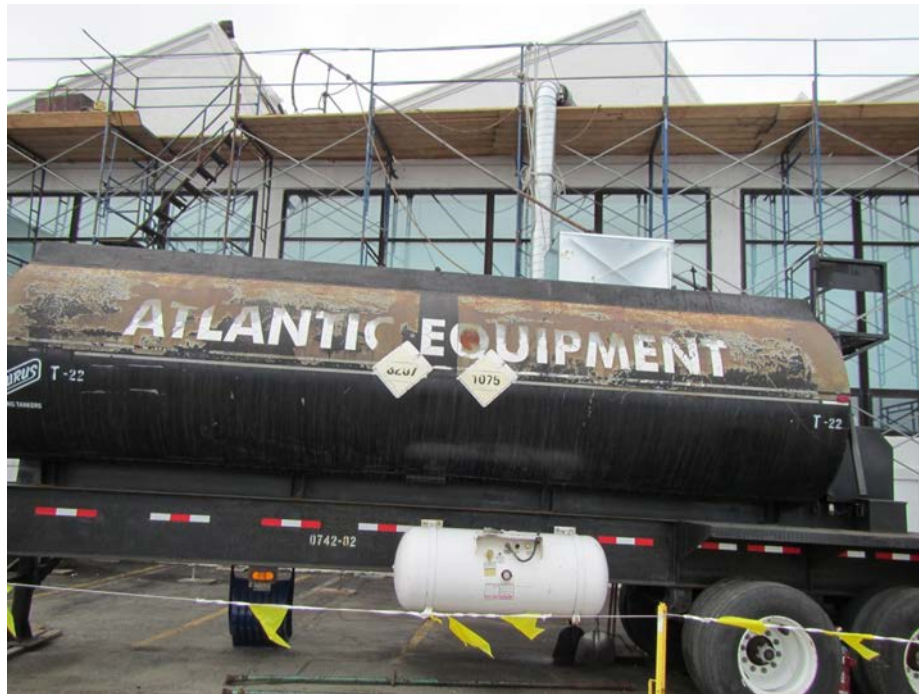
**Picture 1**

As mentioned, the primary reason for this assessment was to investigate complaints regarding roofing tar odors in the office space. At the time of the first assessment on March 1, 2017, roofing tar odors were detected near the “kettle” located outside at the front of the building but no odors were detected in the office areas (Table 1). The kettle is a gas-fired heater that warms the roofing tar to the proper working temperature (Picture 1). It was reported that roofers were only doing small patch work and stripping old roofing during the March 1 assessment and were not applying the roof tar to large sections of roof (Picture 2). Occupants reported that the odors were strong on the day previous to this assessment (February 28, 2017). Some occupants reported headaches, eye irritation and nausea during the previous roof work before BEH was notified of the project.

**Roofing tar “kettle”**

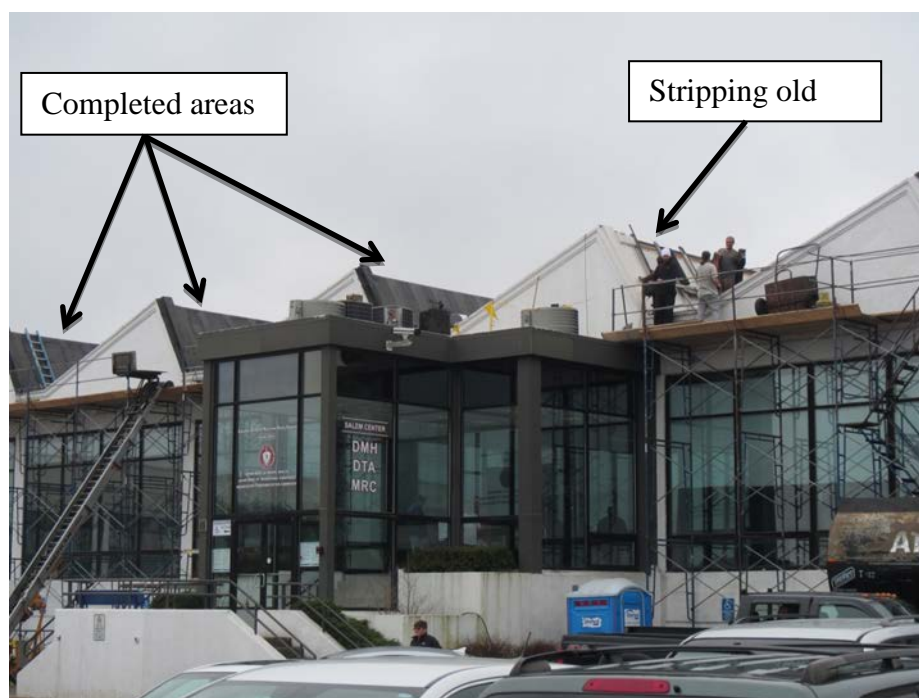
**Picture 2**

**Workers set up to strip old sections of roofing (note completed areas to left)**

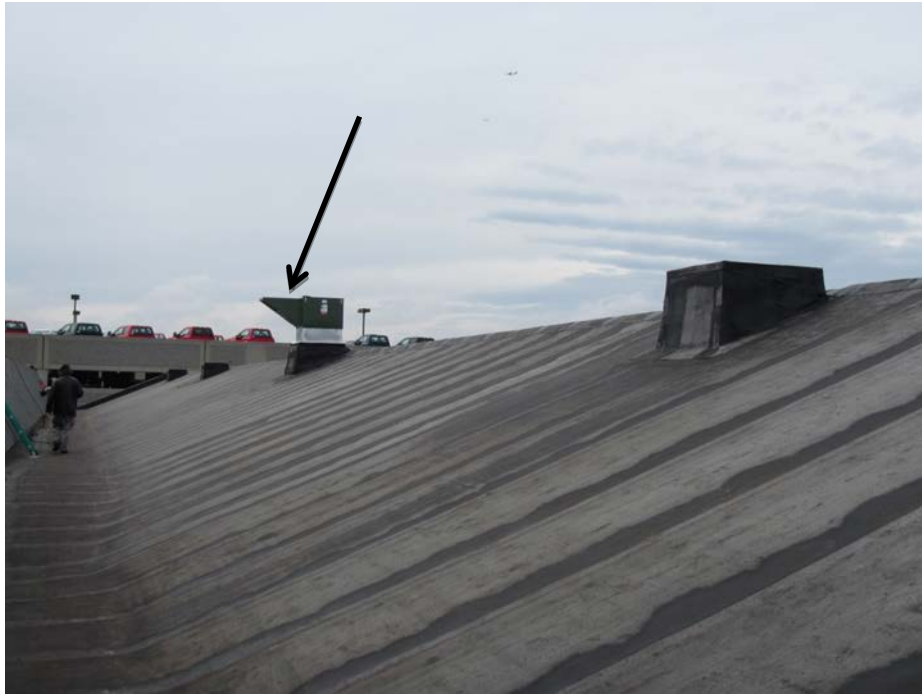
**Picture 3**

It should be noted that Shetland Park maintenance staff reported that due to the ongoing roofing project, the fresh air intakes for the AHUs were closed to avoid the entrainment of roofing tar odors (Picture 3). The MDPH typically recommends that all construction work producing strong odors or particulate matter be performed while the building is *unoccupied*. In cases where this work cannot be performed during unoccupied hours, the temporary closing off

of fresh air intake vents near active work zones is a method used to prevent the entrainment of odors and particulate matter. Due to the lack of fresh air intake functionality, the buildup of commonly-found indoor air pollutants may result. This decreased air exchange can be seen with the slightly elevated carbon dioxide levels shown in Tables 1.

**Fresh air intake (closed) in area of active roof work**

2. Implement recommendations from the BEH letter that was sent on March 2, 2017 which is included as Appendix A.
3. Provide temporary mechanical means of fresh air to space while fresh air intakes are closed due to roof work. This can be done by use of portable AHUs and flexible ductwork.

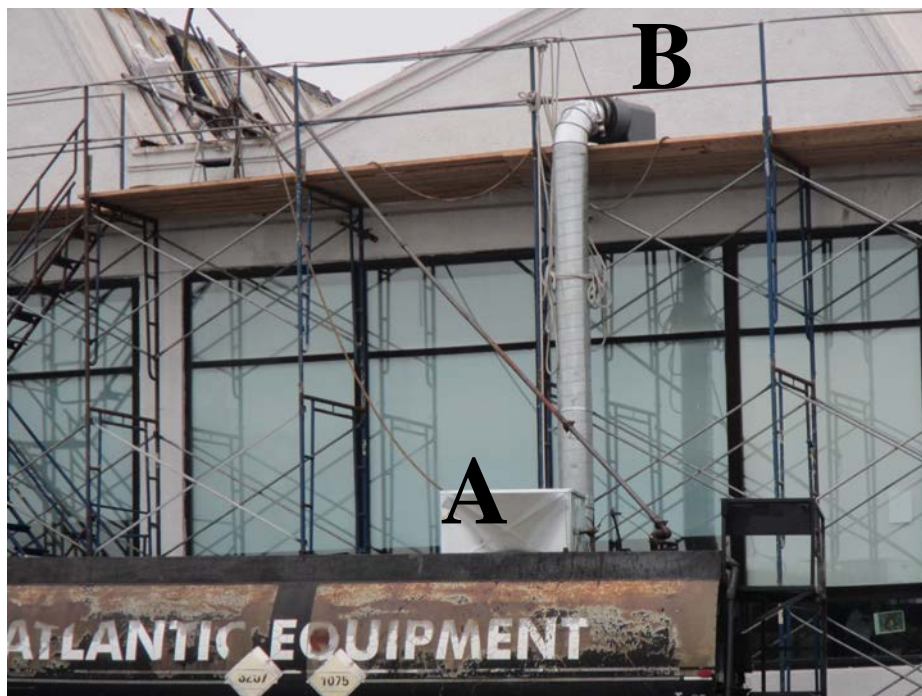
**Picture 4**

In addition to closing fresh air intakes near work zones, a kettle venting apparatus was installed to capture tar fumes from the kettle area and exhaust them above the roof (Picture 4). Occupants reported that this had improved odors in the waiting room and cubicles in close proximity of the kettle at the front of the building. Future adjustments to the venting height may be necessary if fumes are not dispersed adequately. This is due to the tar fumes having a vapor density of approximately five times that of air.

**Kettle venting apparatus showing collection (A) and venting (B) areas**
